PRELIMINARY DRAINAGE REPORT

DRIEDGER DRAIN

(Situated adjacent to north side of Mersea Road 6)
(Geographically former Township of Mersea)

1 June 2016
File No.: 14-391

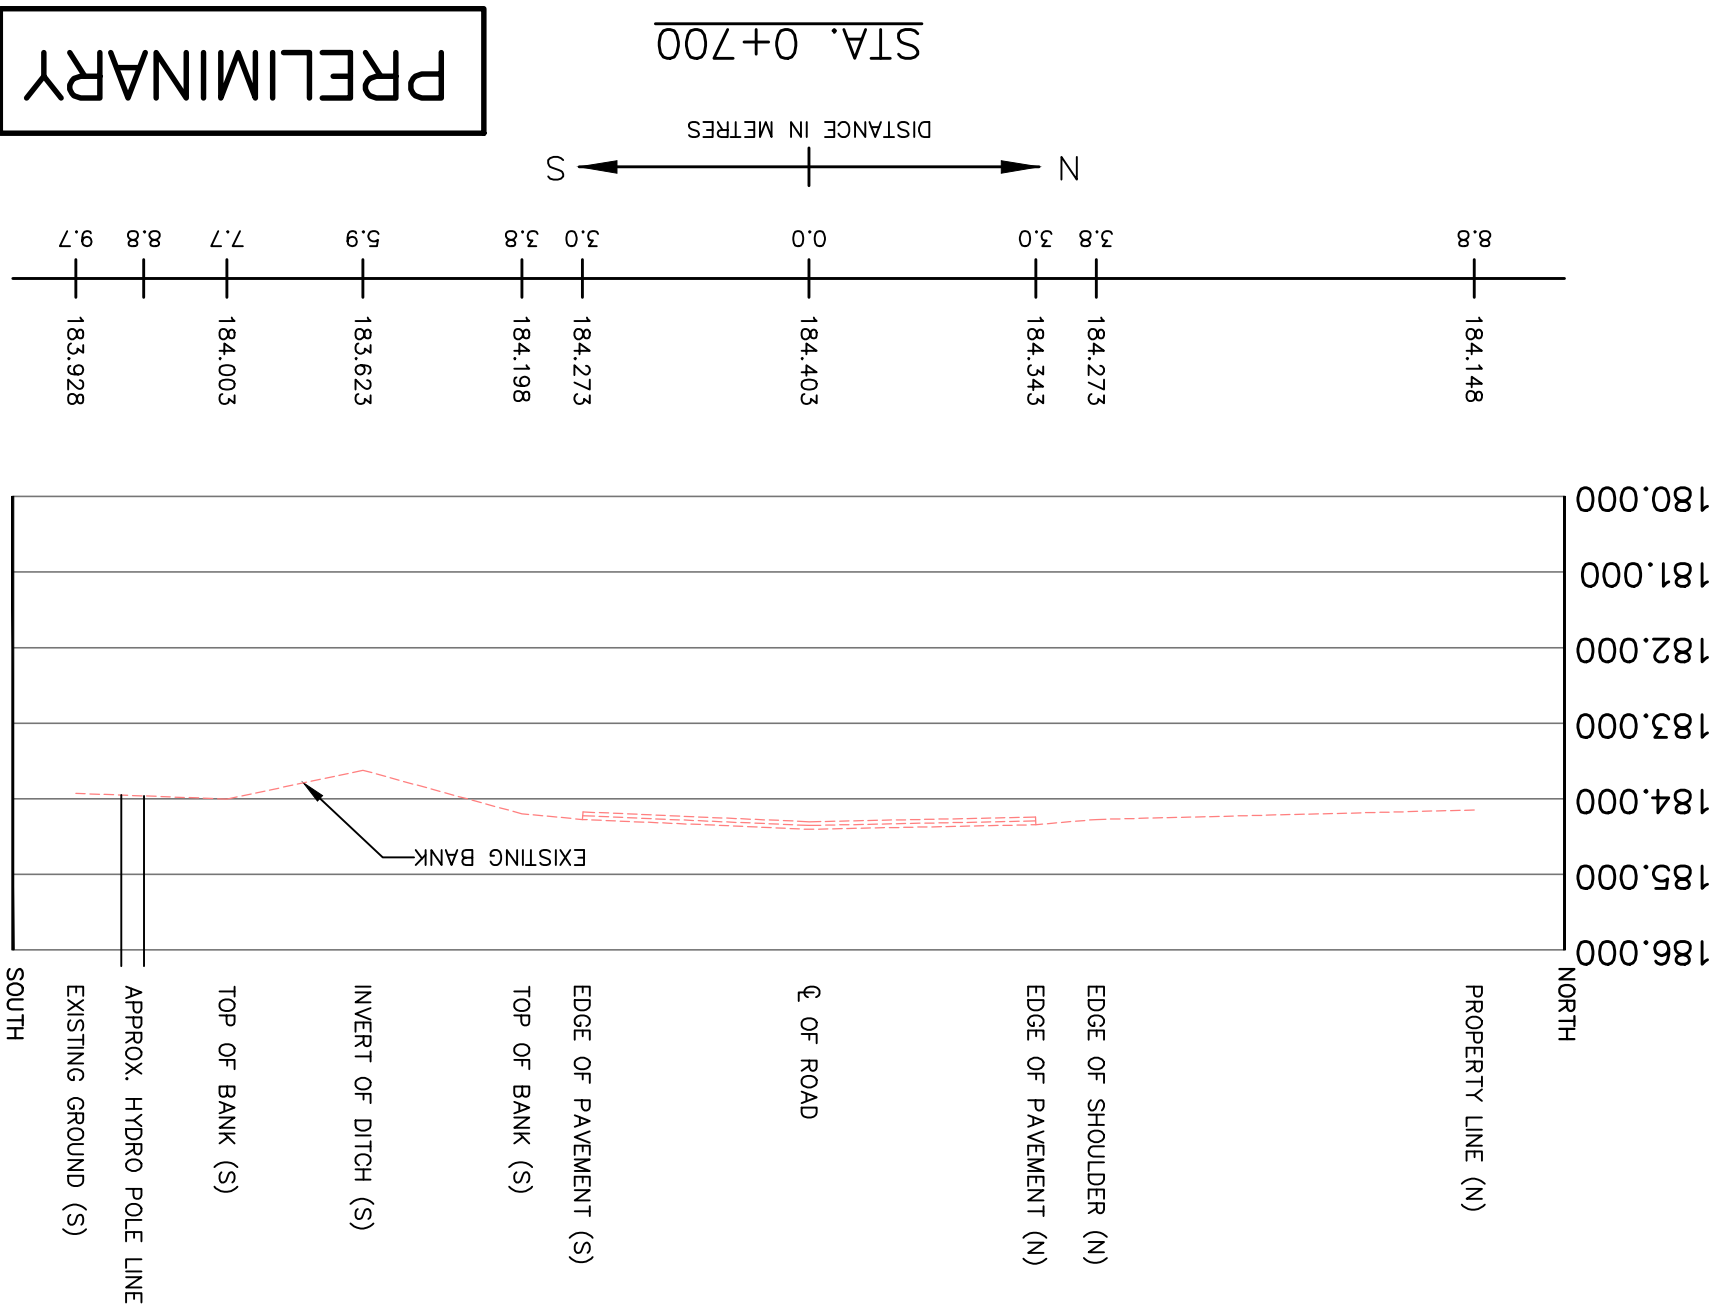
| b) Cross Sections (Station 0+000 to Station 0+700) | Drawing Number 2 |

On September 2, 2015, geodetic elevations were taken on the Mersea Road 6 roadside ditch bottom and top of water and top of bank every 25 metres, and full cross sections every 100 metres using standard survey equipment.

The existing ditch along Mersea Road 6 is currently an open roadside ditch along the north side of the road with a top width varying from approximately 6.0 to 6.5 metres from Station 0+000 (at Derbyshire Drain) to Station 0+486 metres westerly. The ditch then crosses Mersea Road 6 at Station 0+486 via a 300mm diameter culvert to the south side of the road

and continues westerly to Station 0+700. The top width of the ditch along the south side of Mersea Road 6 is 3.5 to 4.0 metres wide.
