Preliminary Report For the Gorrell Drain

The Municipality of Leamington

Project No. 14-163

Subject: Preliminary Drainage Report – Gorrell Drain
In the Municipality of Leamington
Our File Reference 14-163

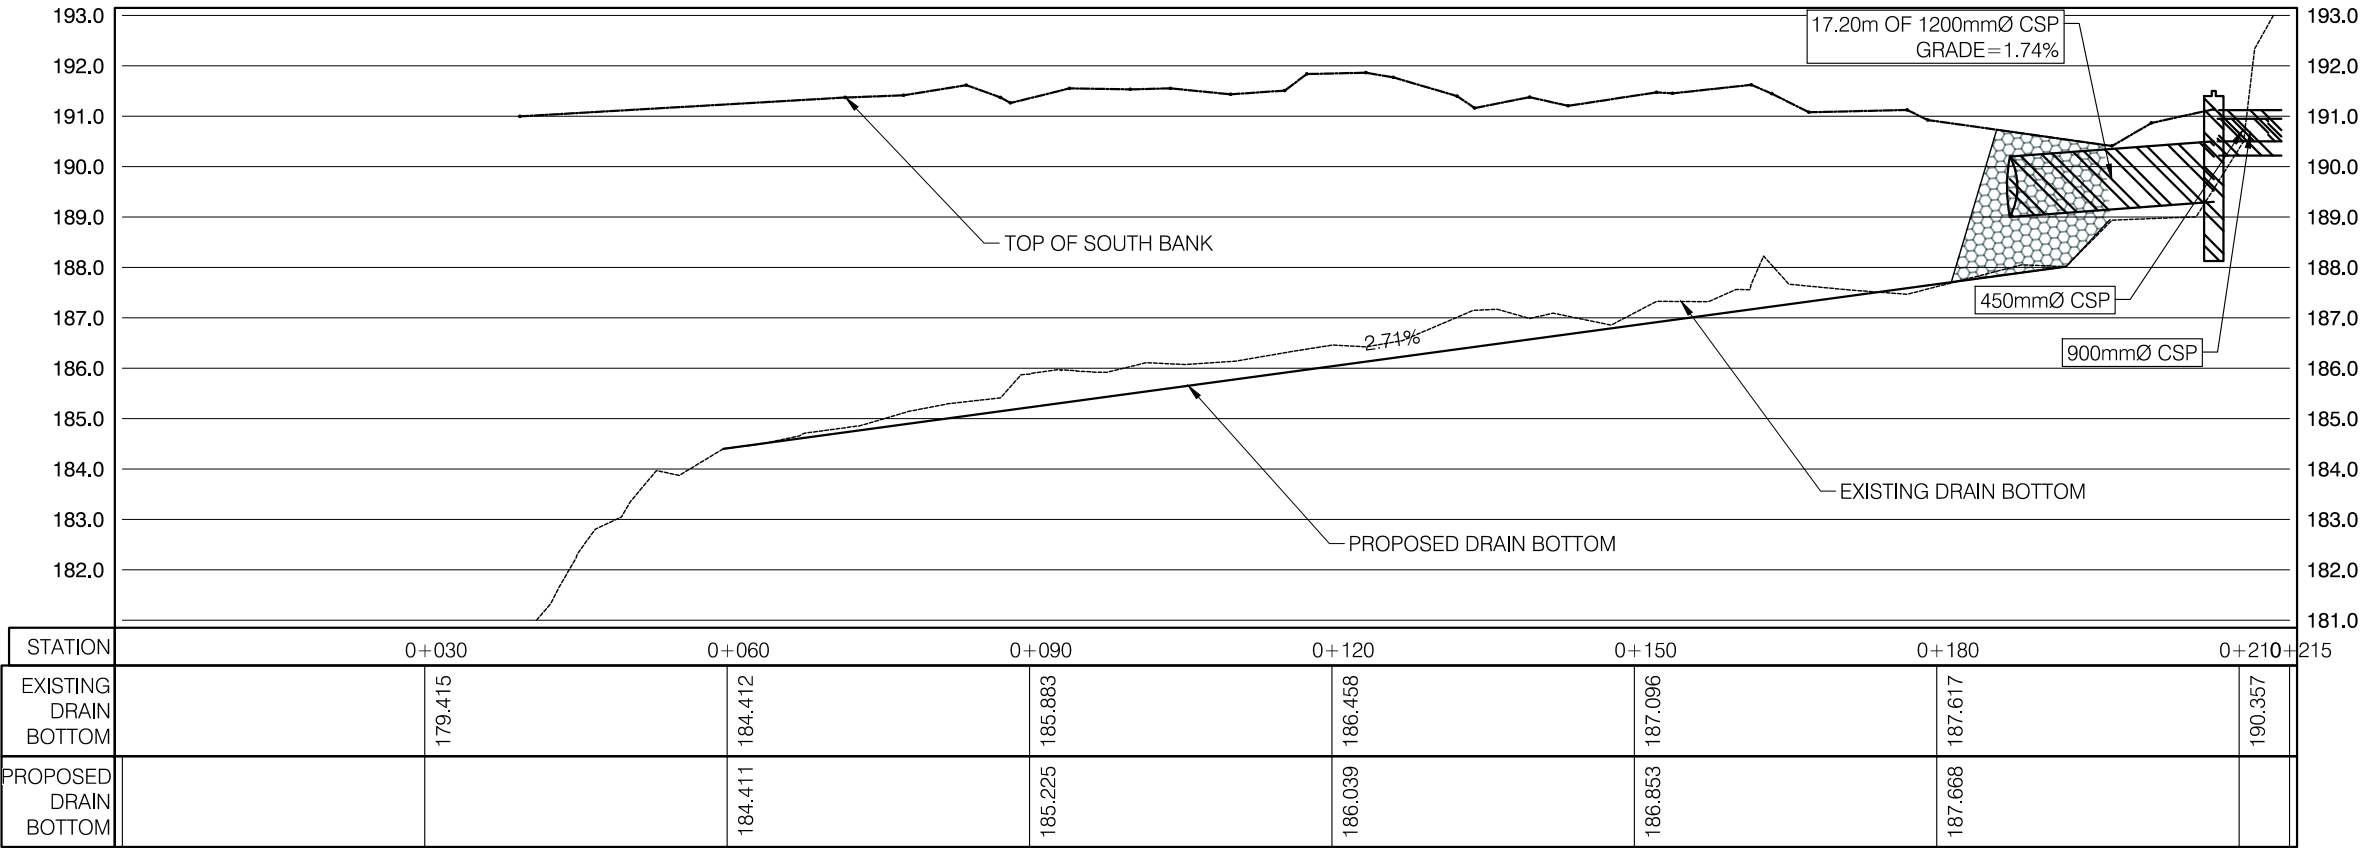
PROFILE VIEW
HOR: 1:750
VER: 1:150

PROJECT TITLE: REPAIR AND IMPROVEMENTS TO THE GORRELL DRAIN			
LEAMINGTON, ON			
SHEET TITLE: GORRELL DRAIN - PROFILE VIEW	DRAWN BY: D.B.	SCALE: AS NOTED	DATE: AUGUST 1, 2017
	CHK'D BY: D.A.J./H.P.P	SHEET No. : 3 OF 7	PROJECT No. : 14-163
